I. INTRODUCTION

The North Carolina Department of Transportation (NCDOT) is making improvements to U.S. Highway 1 in Lee, Chatham, and Wake Counties, North Carolina (TIP No. R-2500). Part of the project includes the replacement and construction of the US Highway 1 bridges over the Deep River at the border of Lee and Chatham Counties (Figures 1 - 4). These bridges cross through a National Register property known as the Lockville Dam, Canal and Powerhouse Site (State Site Number 31CH 690).

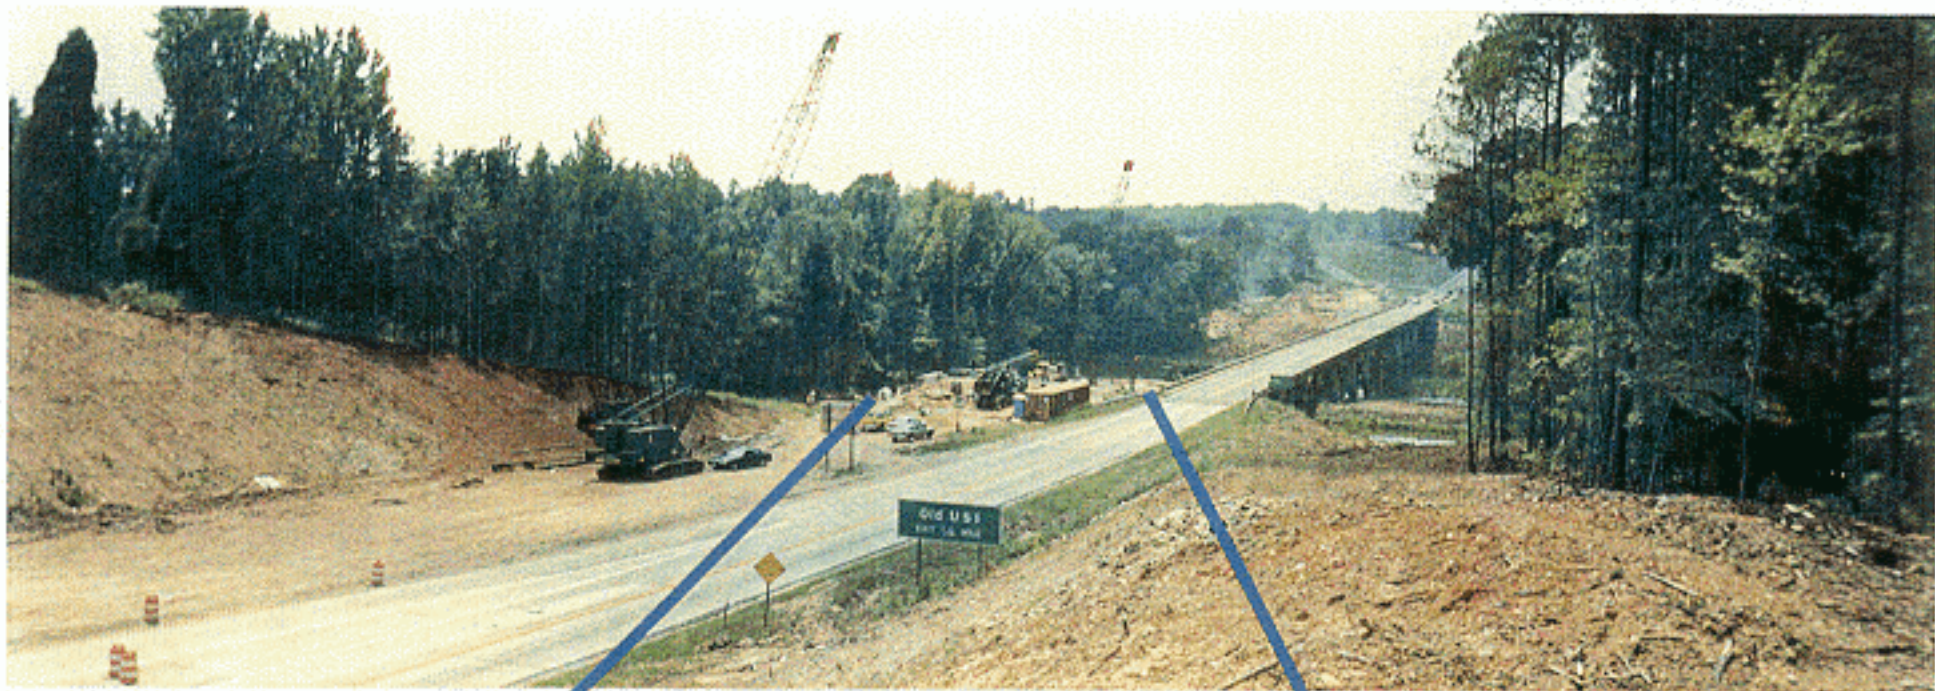
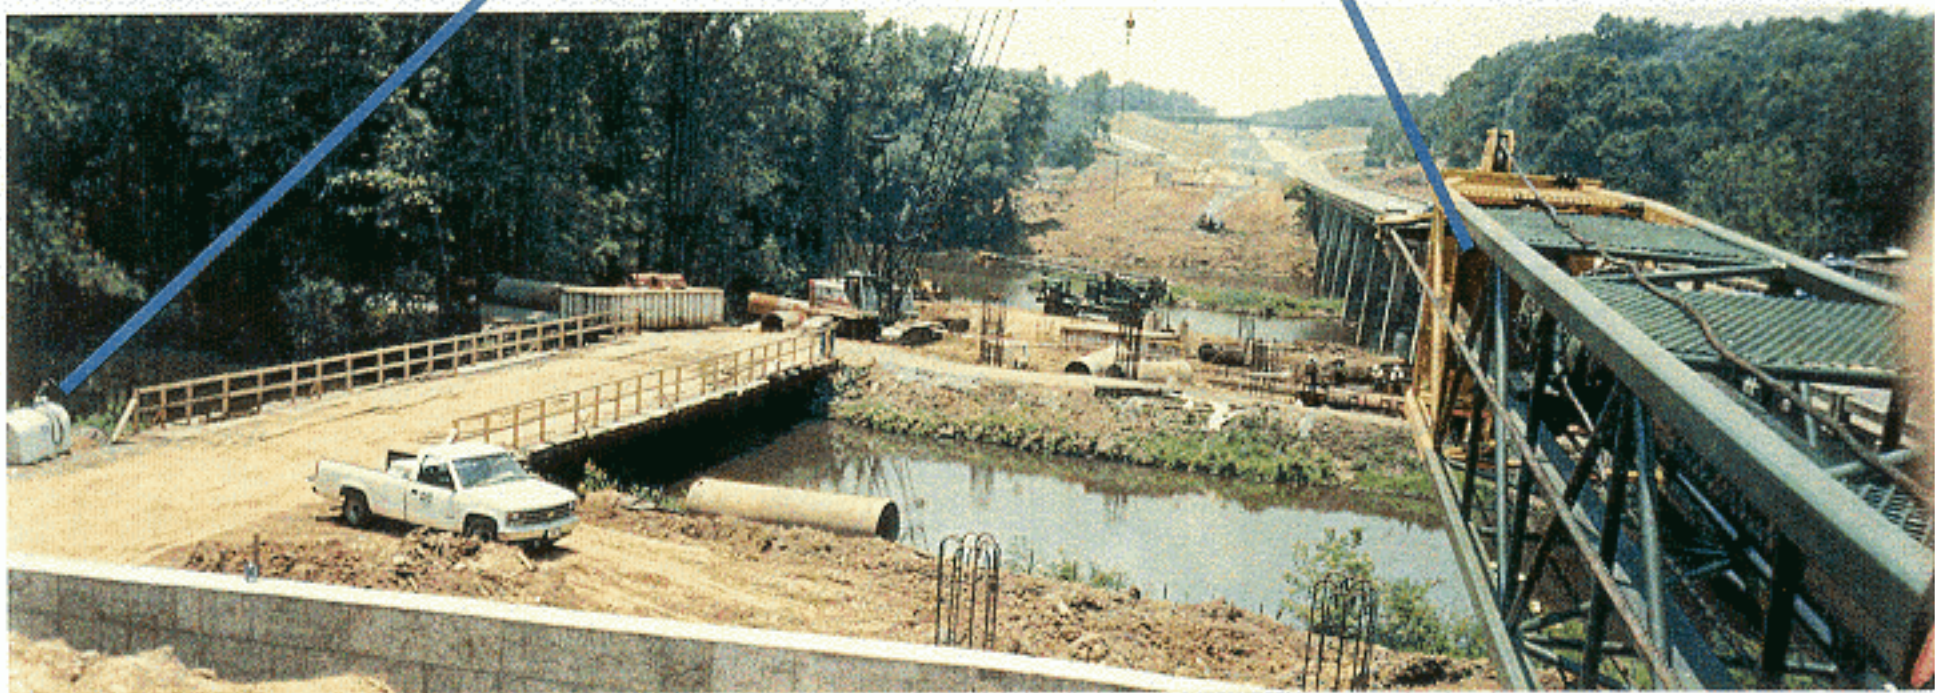
Figure 3. General Views of Project Area and Lockville Canal

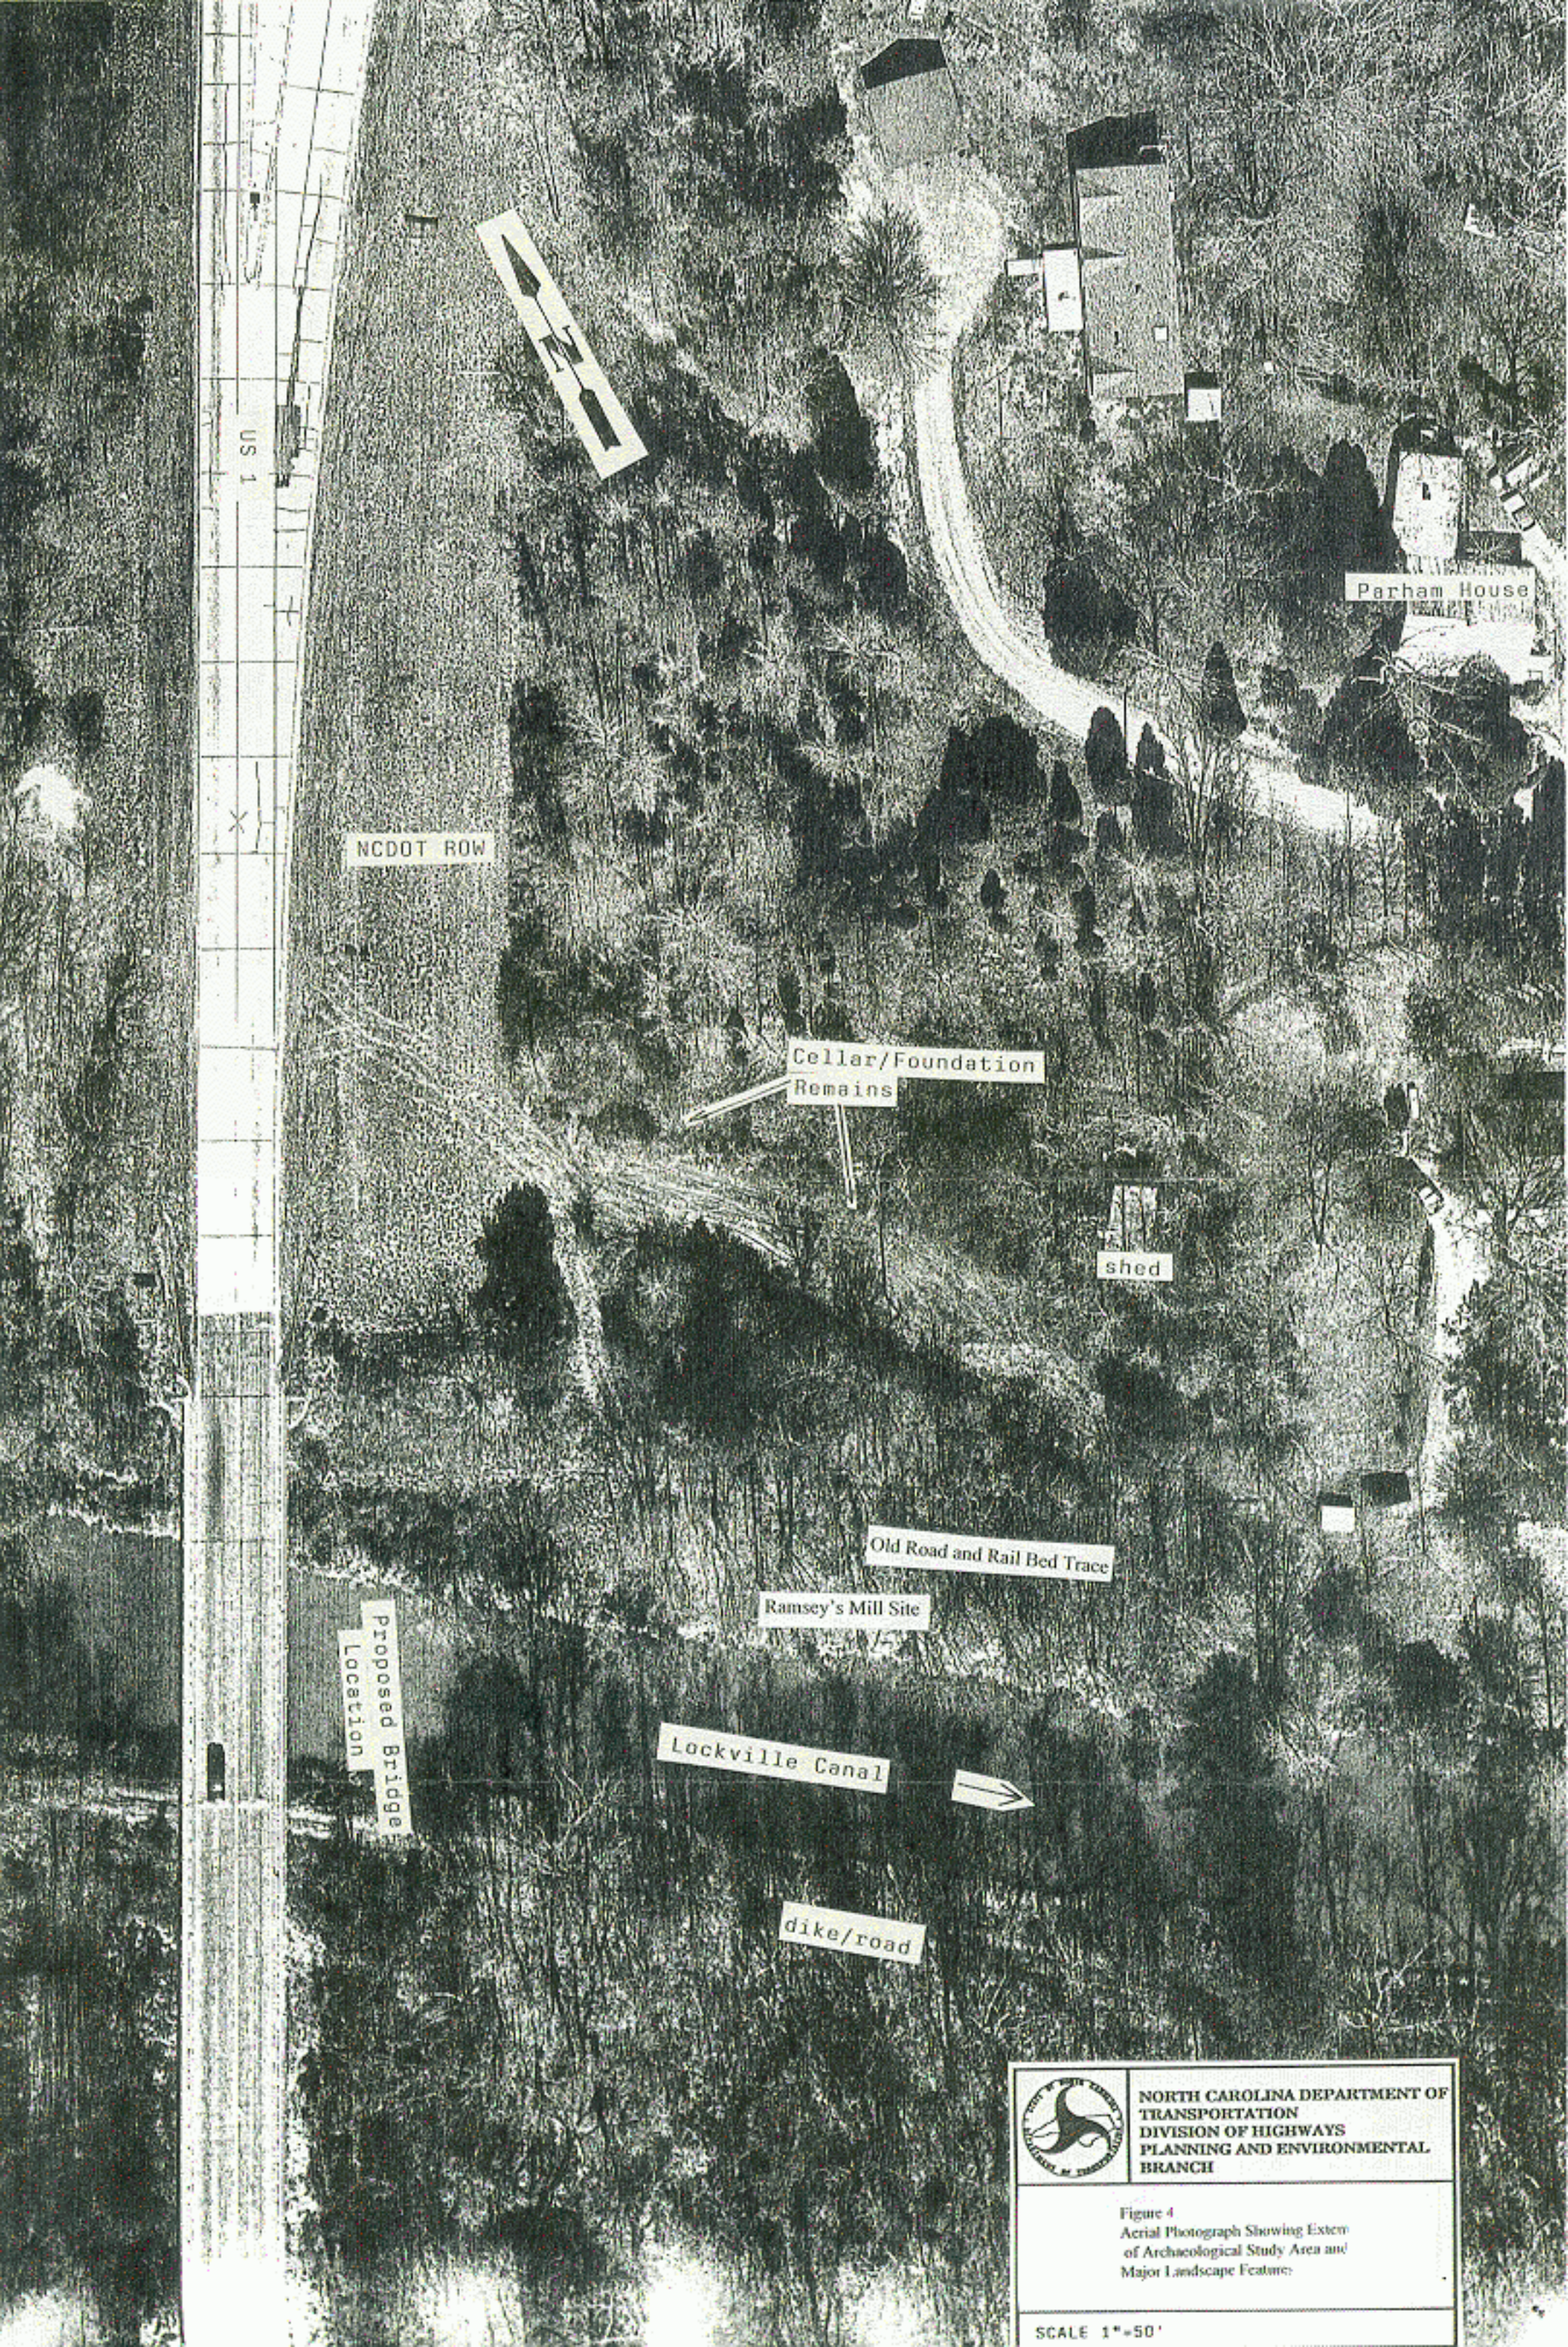
Figure 4
Aerial Photograph Showing Extent
of Archaeological Study Area and
Major Landscape Features

features or remains (Figures 4 - 6). The archaeological study resulted in the documentation of several very large and prominent features associated with the historic Ramsey's Mill and the historic village of Lockville, a small community that developed along the Deep River in the 1850s next to the Lockville Canal, Lock and Dam complex. Archaeological features documented during the investigation included a terraced hillside with stone retaining walls, the remains of a miller's house, a subterranean cellar and well, and the foundations of a store structure which faced onto the canal. Also investigated were the foundation and spill pond of Ramsey's Mill, a prominent nineteenth century industrial site with origins in the late eighteenth century.

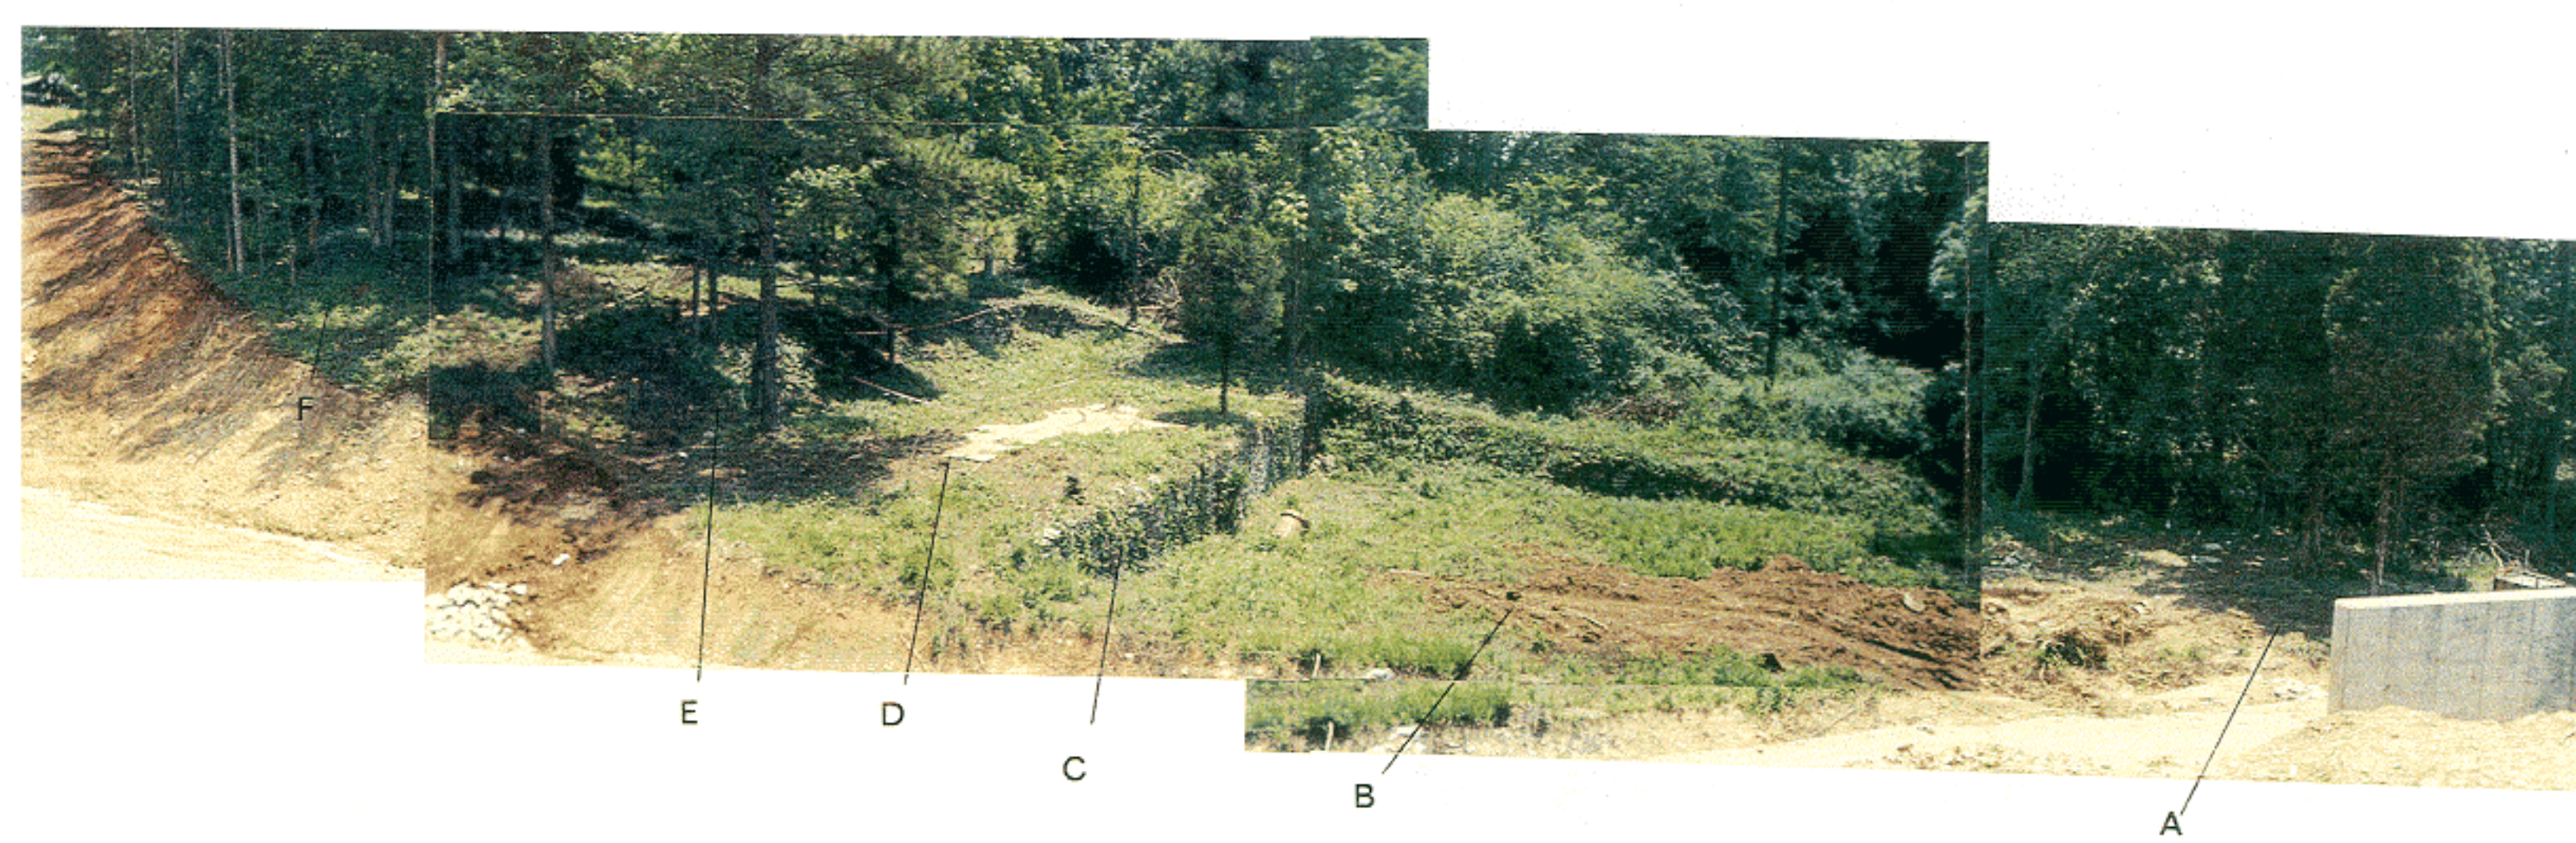
Figure 5. General View of Archaeological Study Area (facing east). (a) Store Mound; (b) Lower Terrace; (c) Wall 1; (d) First Terrace; (e) Wall 2; (f) Upper Slope.
